Building 910 Sub Project Special Assessment Findings

# Rocky Flats Plant Building 910 Evaporators Precursory Failure Modes and Effects Analysis

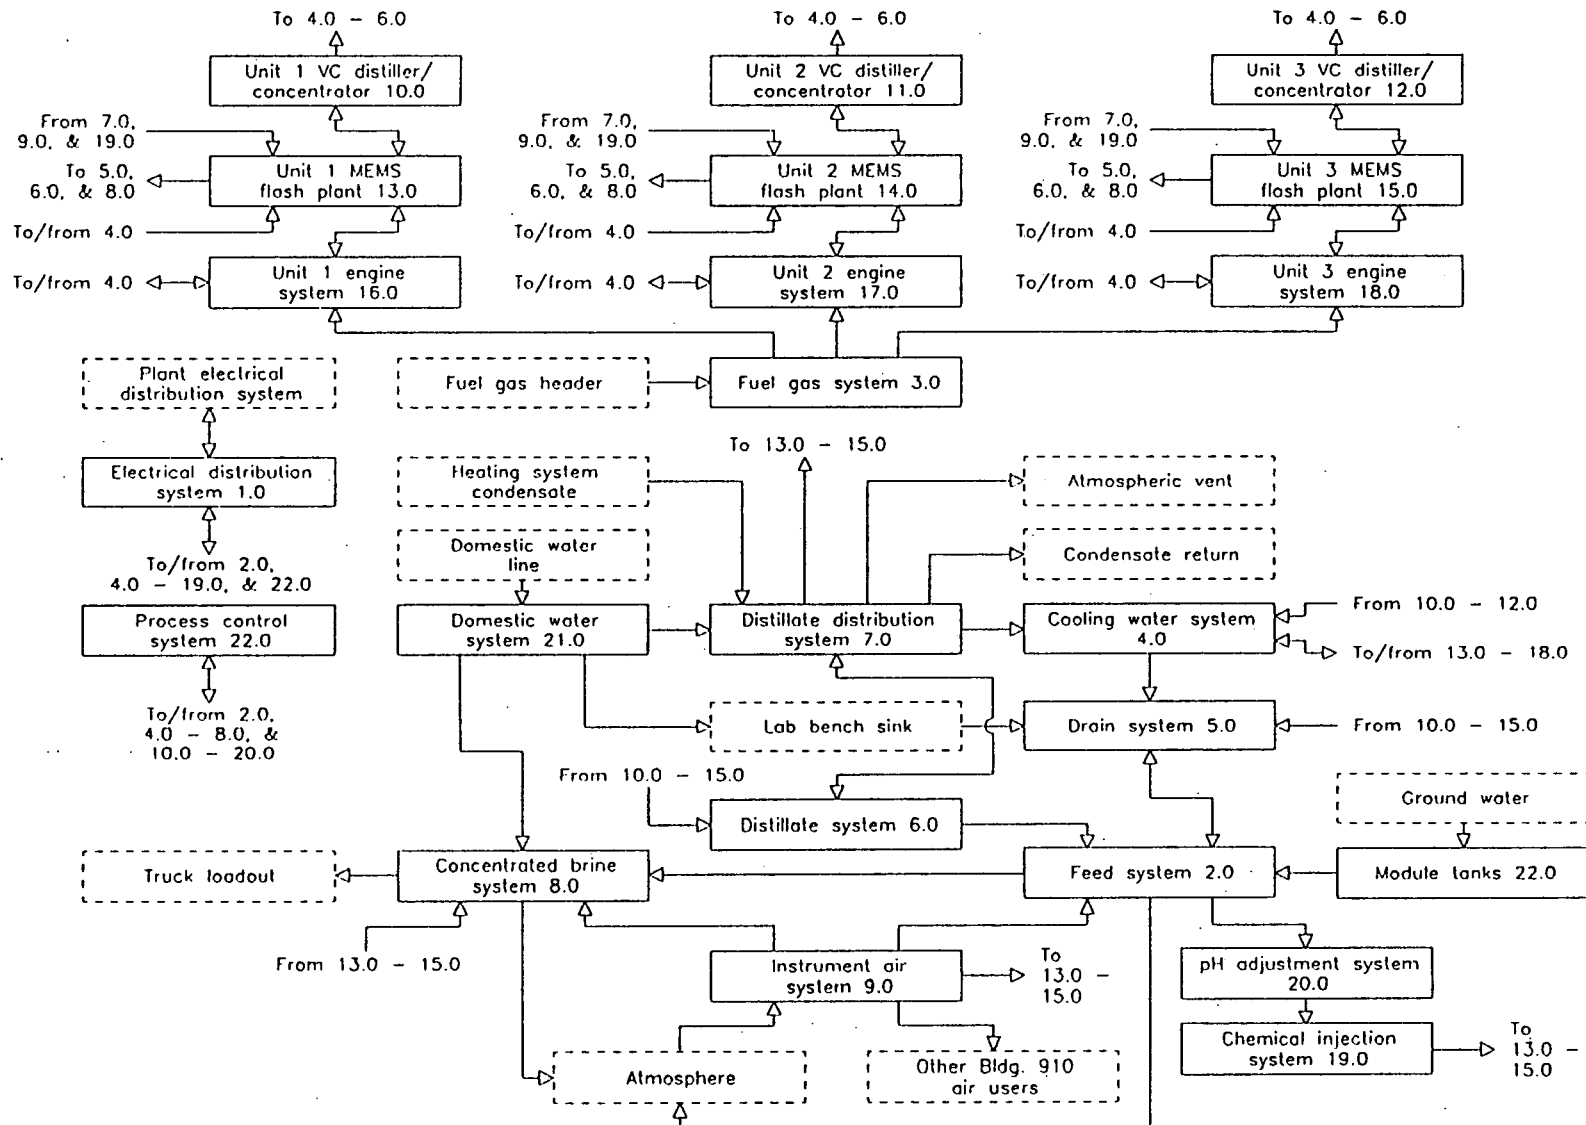
Figure 1. Rocky Flats Plant Building 910 Evaporators Functional Flow Block Diagram.

This analysis is concerned with the failures of the Rocky Flats Plant Building 910 Evaporators. The failures of concern are 1) single failures and/or combinations of two failures that could lead to deposition of feed water into the raw water or condensate systems, and 2) failures that could lead to excessive down time (i.e. several months). This analysis considered common mode failures for the Building 910 evaporators utilities - the electrical distribution system (1.0), the fuel gas system (3.0), the instrument air system (9.0), the domestic water system (21.0), and the process control system (22.0). The remaining sections of the Building 910 evaporators were considered at a subsystem level of inquiry.

There are two results to this analysis. The first is the failure modes of concern for the Building 910 evaporators. This have been noted in the analysis. Most of these failure are rare due the scarcity of the failure(s) occurring. However, a few of the failure of concern are either due to operation or can affect the entire plant. The operational failure modes of concern are the opening of the valves MV7005, 1CCV353, 2CCV353, or 3CCV353. The failure that can affect the entire plant is leakage from the distillate into the domestic water supply.
